Air Quality
April 7, 2008-4:00pm Commission Meeting

POINT PAPER

Problem: The results of the City Hall air quality study have been completed and recommendations have been made to improve the air quality. Staff seeks authorization to proceed with the recommendations.

February 20, 2008

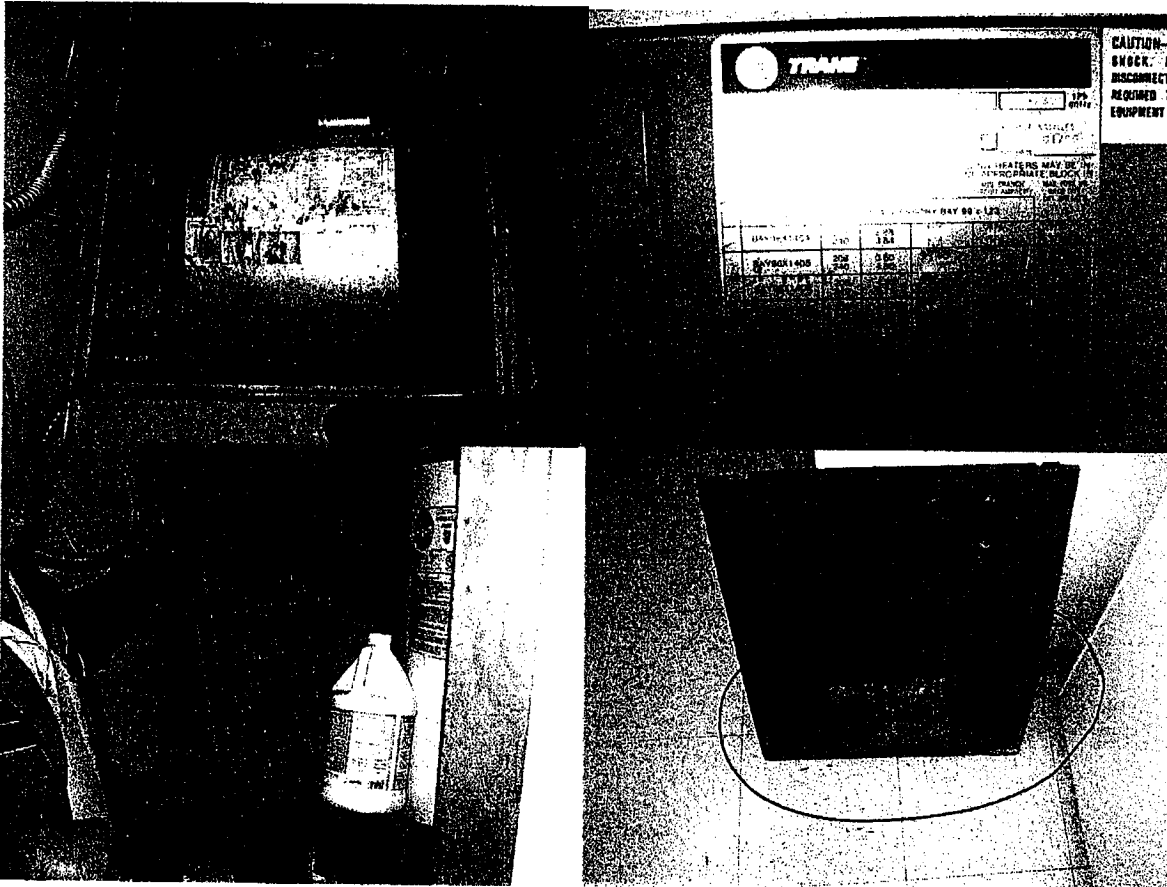
#1 system (Mrs. Jones's office)

This is a 3 ton mismatched heat pump system. The air handler has a manufacturer's date of 01/85. The condensing unit has a manufacturer's date of 03/92.

Mrs. Jones's office has water damage to the common wall between the office and the air handler itself. It also has signs of water damage to the carpeting at this same area. The interior of the air handler is very dirty. We also observed a 16x20 electrostatic filter directly under the air handler. While this filter is made specifically to collect more of the dust and dirt particulates, it also has the ability to restrict the air flow dramatically. As such, it is not recommended that this type of filter be installed at the air handler. The ductwork above the air handler is in the same condition as the air handler. The ductwork is very dirty.

Also noted no fresh air makeup is present on this system.

This condensing unit has obvious signs of being partially underwater. This equipment should be raised on a hurricane pad and strapped down per current code.

Due to the age and condition of this equipment, a cleaning and disinfecting is not a viable solution. We recommend a complete equipment system replacement. Also the addition of a duct cleaning would be needed with the installation. A secondary drain pan with float switch, or at least an in-line float switch, should be installed at the air handler to alleviate water damage and contamination of the area in the future.

Regular maintenance is recommended in six month increments.

The ceiling tile in this area needs to be replaced. Ceiling diffusers are also required for proper air distribution. Some of the diffusers throughout the building need to be repositioned for better distribution.
